RE: Site Inspection, Lakeview Rock Products, Lakeview Quarry, M/035/020, Salt Lake County, Utah

Date of Inspection: January 9, 2003
Time of Inspection: 9:00 to 11:00 a.m.
Conditions: Sunny, 20's, Hazy
Participants: Scott Hughes, Lakeview Products; Doug Jensen and Paul Baker, DOGM

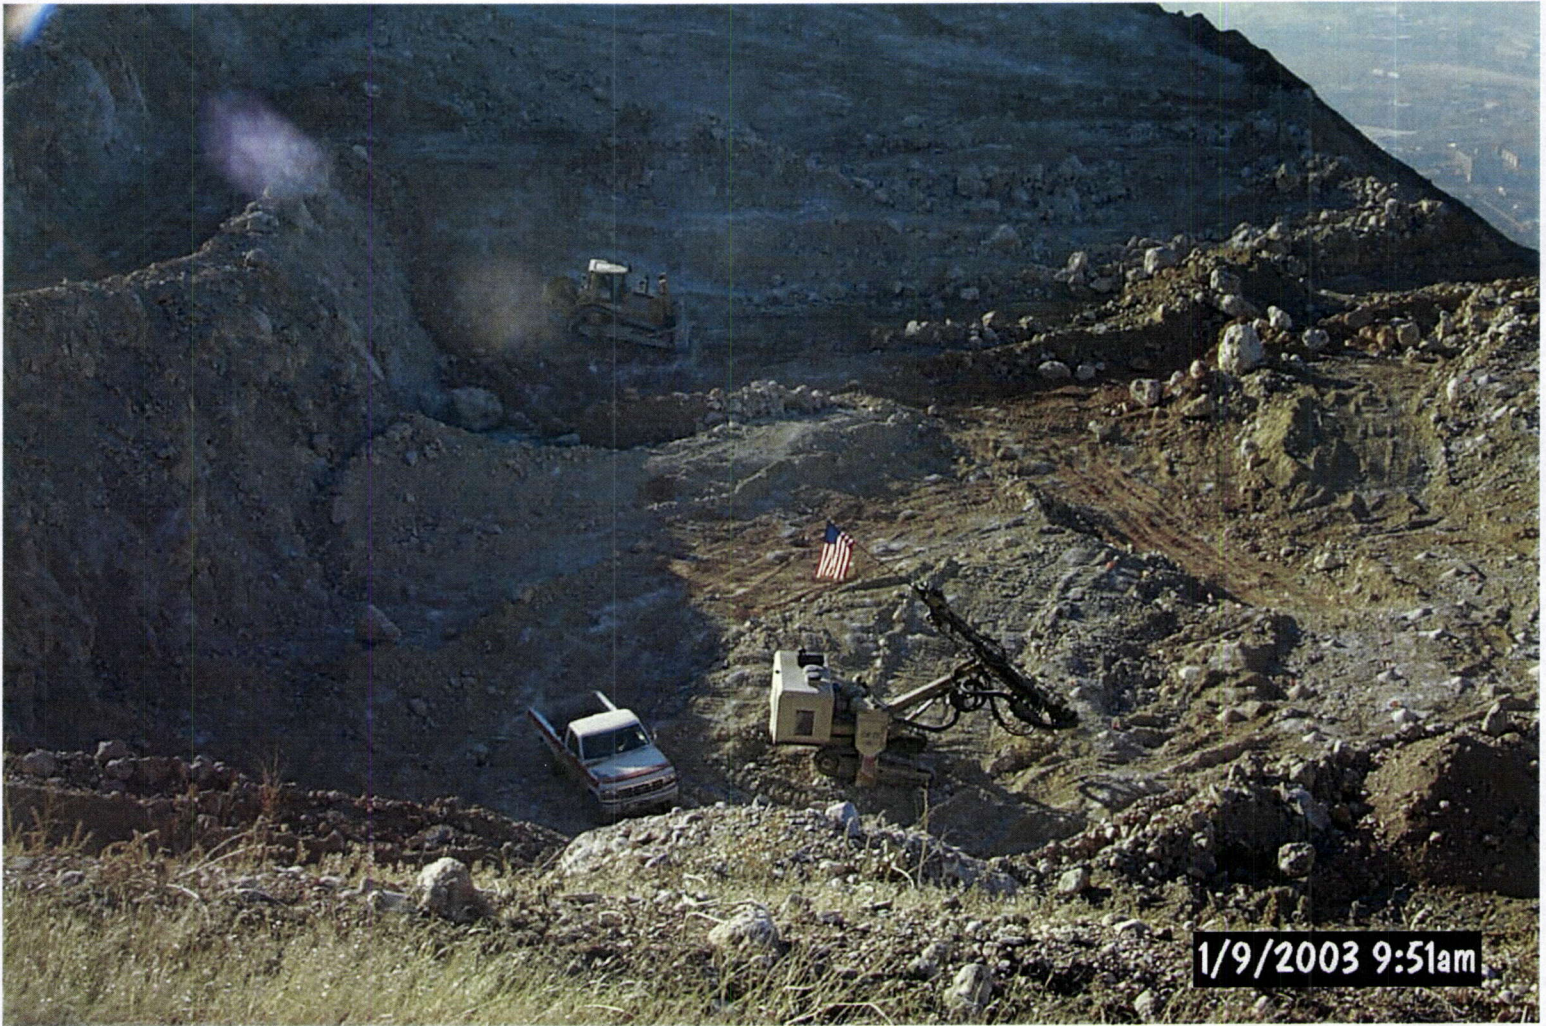
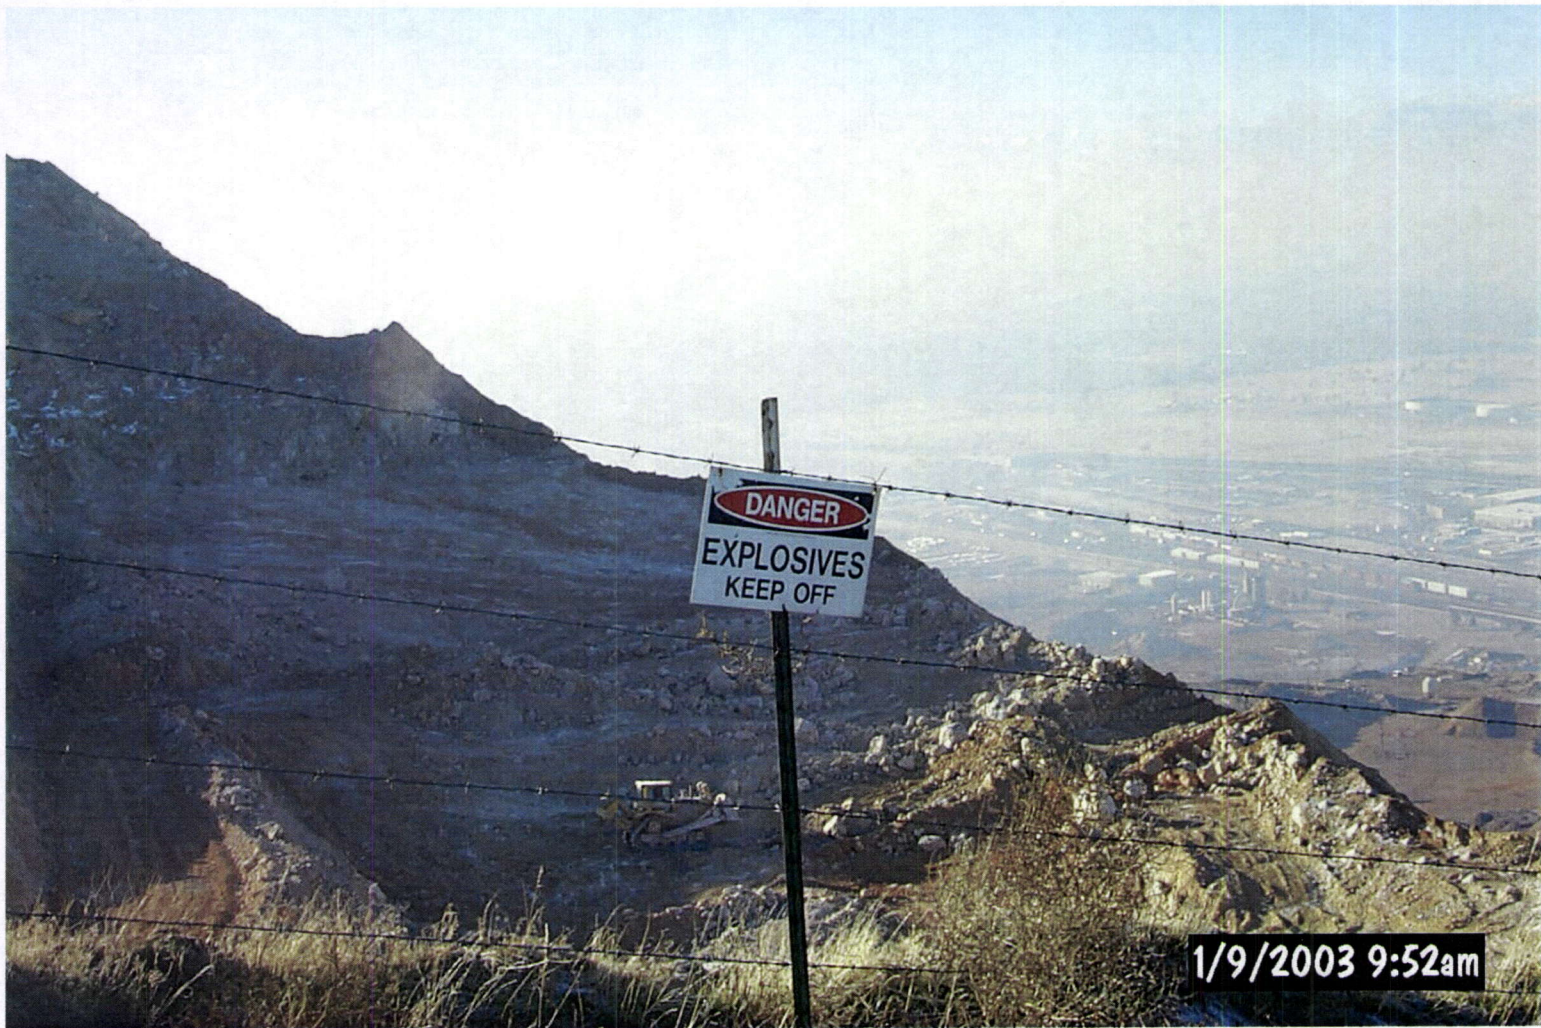
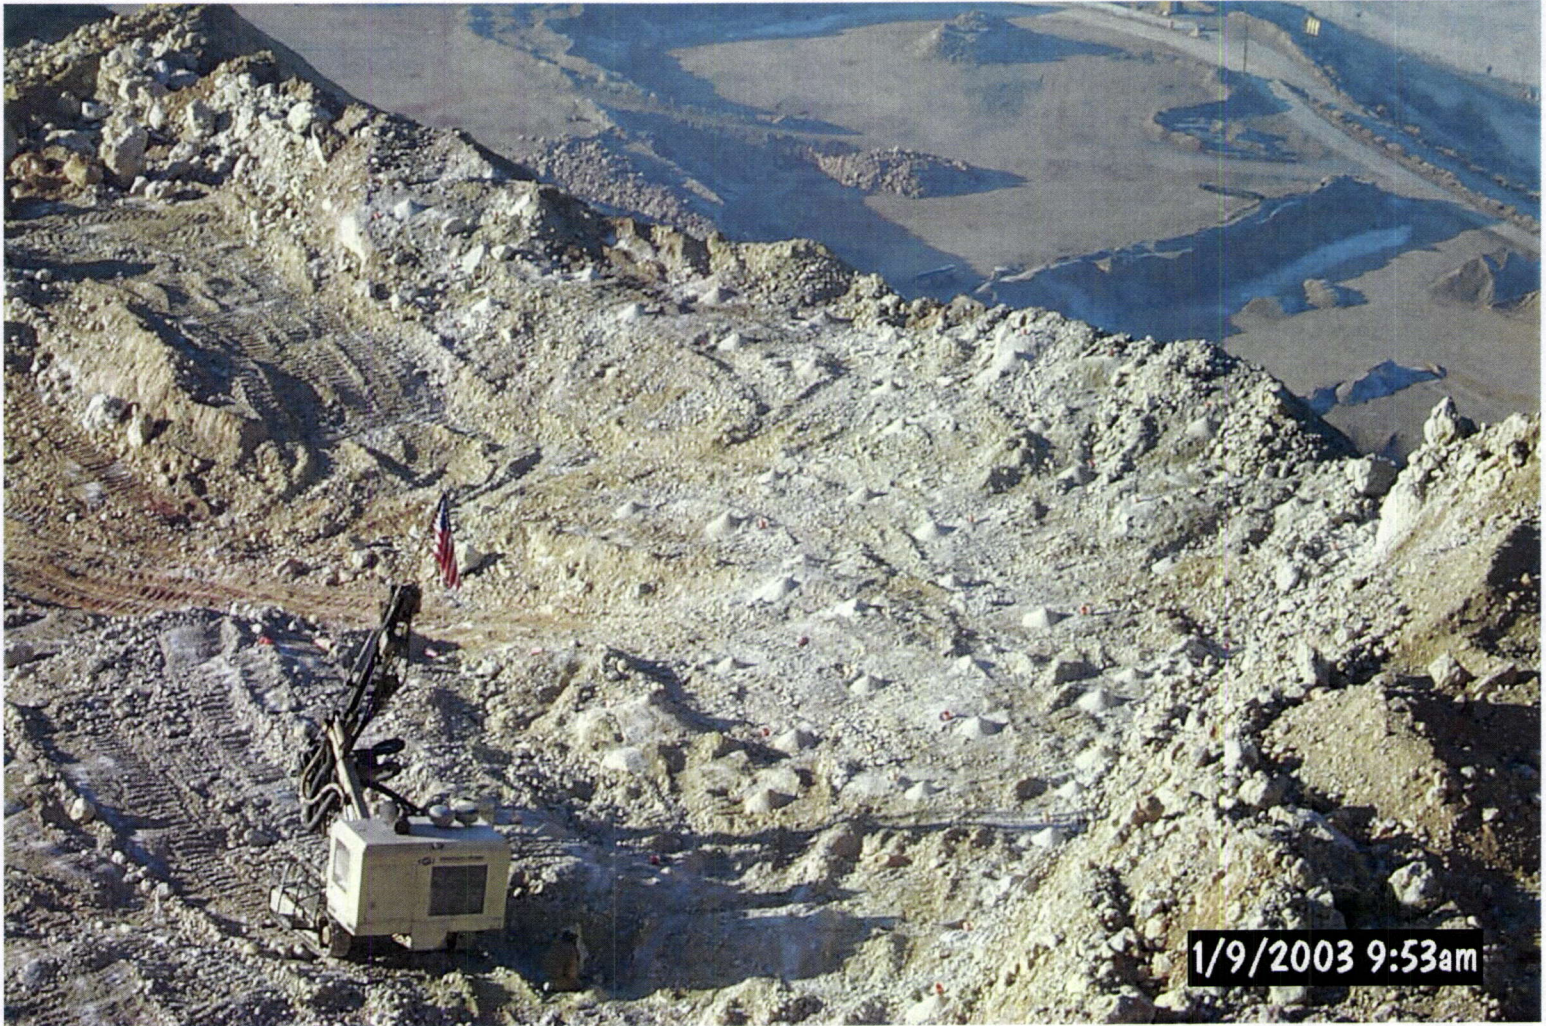
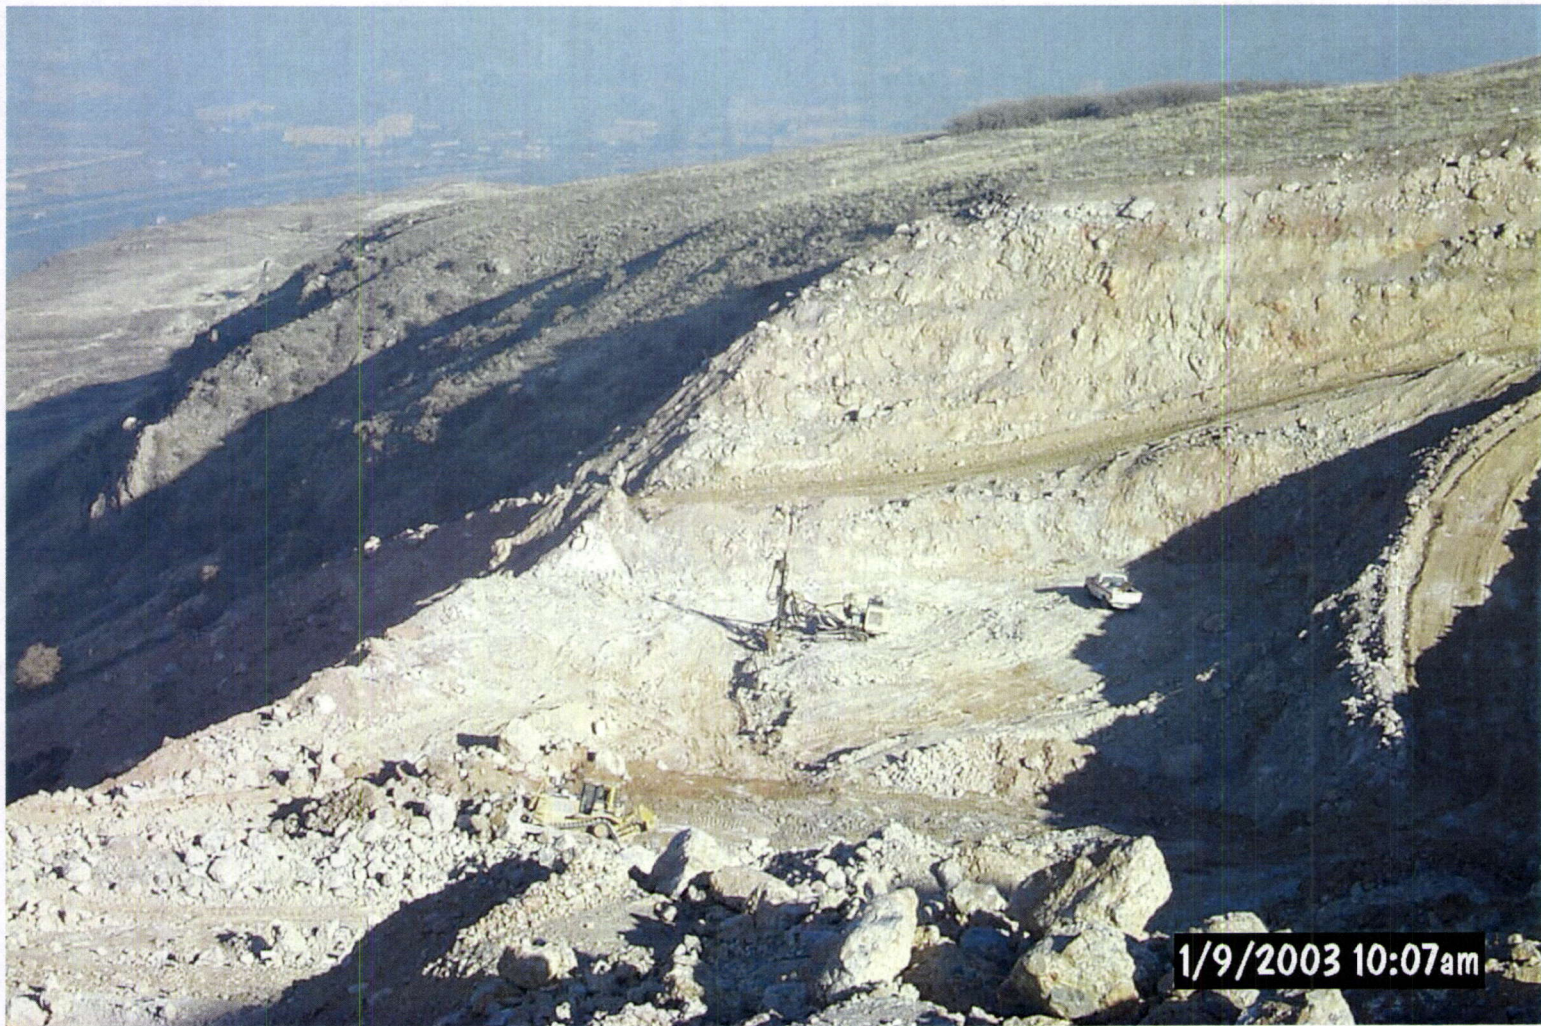
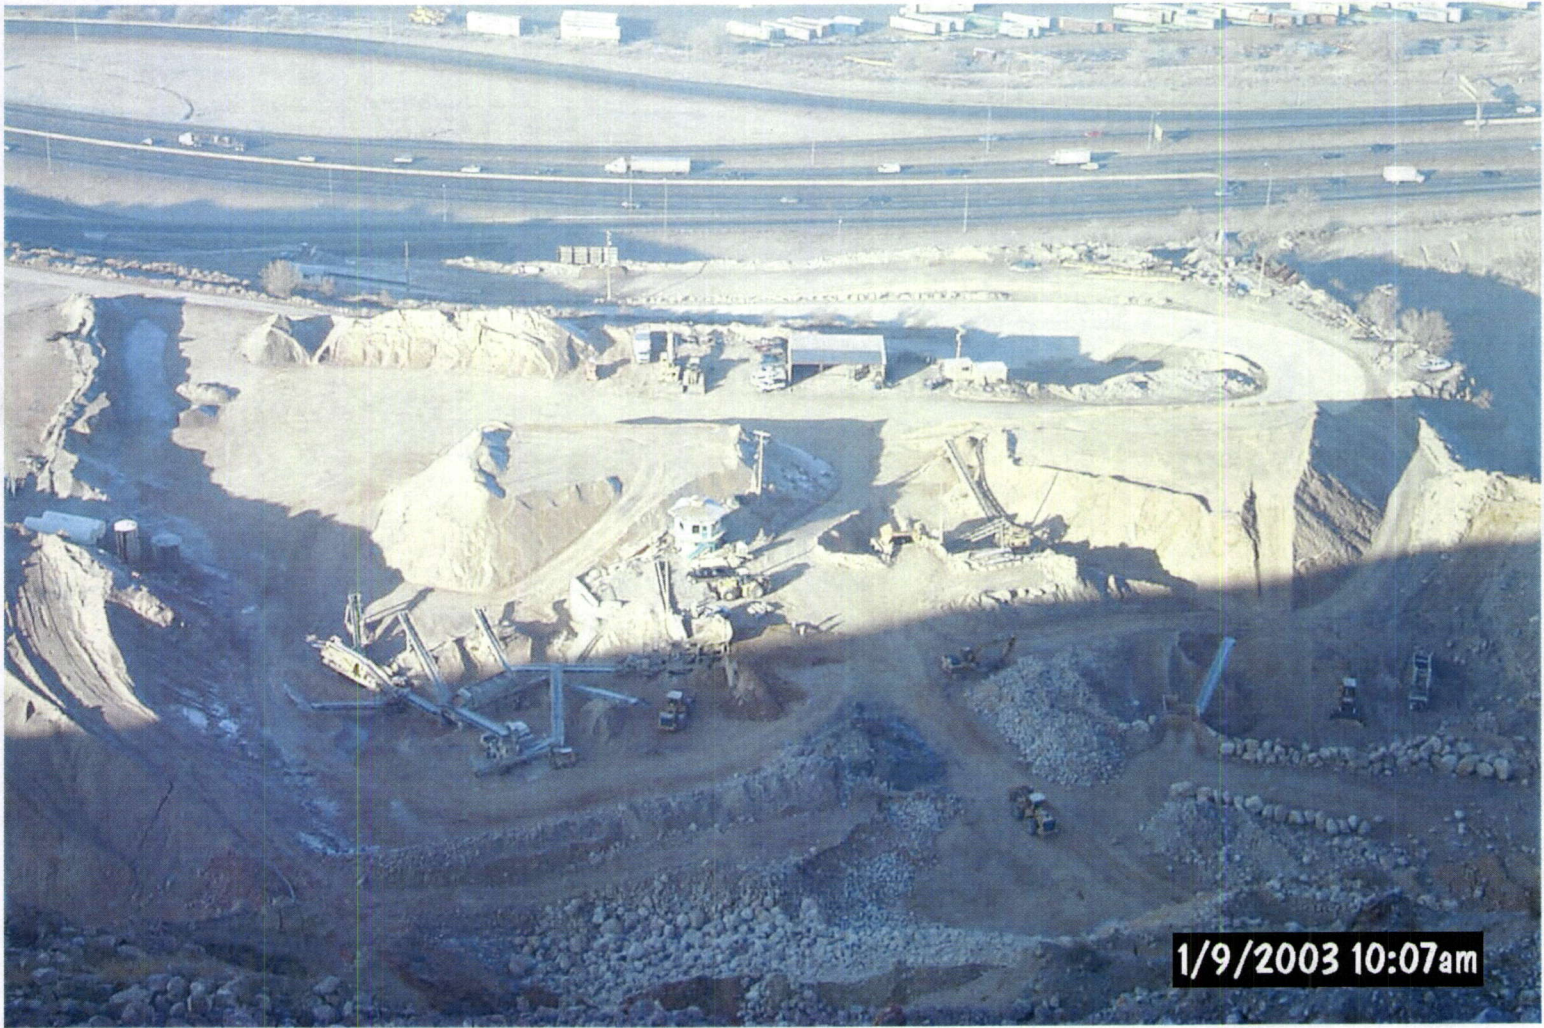
Because the upper working benches were not accessible from the quarry, Mr. Baker and I then drove to an area adjacent to the pit and hiked into the upper working areas of the quarry. A barbed wire fence surrounded the area around the upper quarry, and a sign on the fence read "Danger - Explosives - Keep Off." Operating on this upper bench was a D8 or D9 cat and a small track-mounted drill. There was also a pickup truck parked adjacent to the drill. The drill was working to complete a pattern of holes. These holes were laid out in a manner that lead us to conclude that they were being drilled for the purpose of blasting the underlying bedrock material.

Pictures of the upper quarry area were taken and are attached to this report.

The floor of the upper quarry area appears to be solid bedrock with no alluvial overburden material remaining. In order to continue to remove rock materials from this location, Lakeview will need to drill and blast the bedrock.

As a result of our findings during this inspection, the conditional exemption designation for the Lakeview Quarry should be terminated. Lakeview Rock Products should be required to file all appropriate permitting information with the Division.
